**Savannah River
Remediation**

CAB - Full Board Meeting

STATUS OF THE 3H EVAPORATOR SYSTEM

SRR-TFO-2018-00054

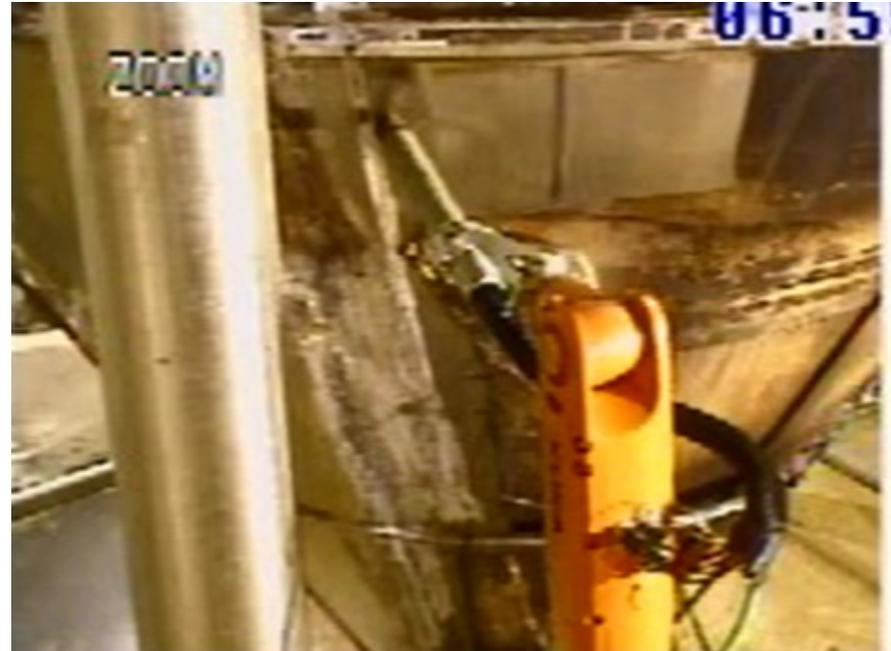
- On February 17, 2016, the 3H was shutdown after salt waste was discovered in the stainless steel-lined concrete cell
 - Leaked ~3000 gallons into secondary containment
 - Leak rate 150 gallons/day
- Extensive testing was performed to pinpoint the source of the leak
 - Including the remote removal of the encased insulation on the cone of the pot using robotics
- Leak site location was confirmed on February 28, 2017 after insulation removal

Picture taken during removal of the stainless steel-wrapped insulation on the cone of the evaporator pot

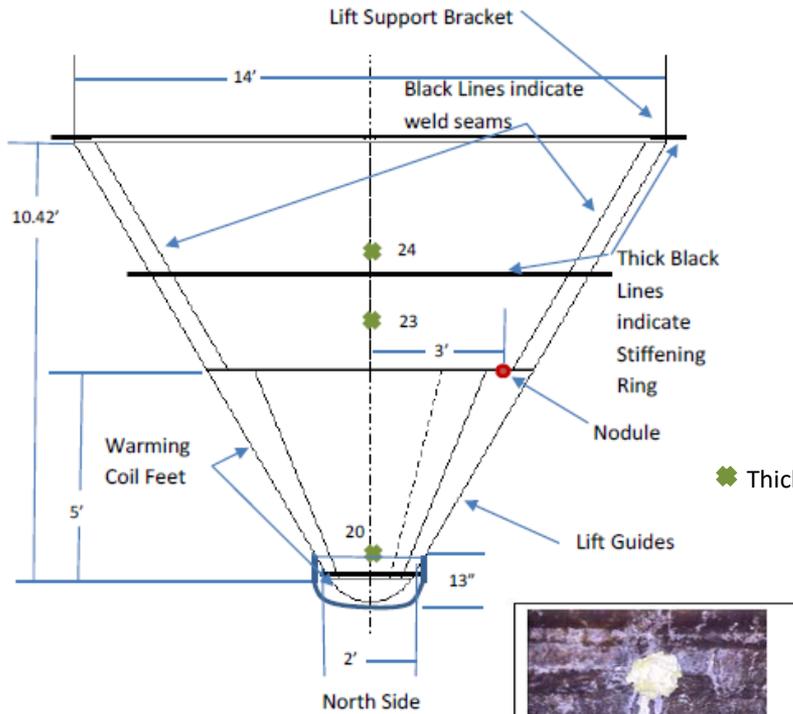
North Leak-site (the nodule)

- Leaks are at welds
- Leaks are approximately the diameter of a human hair (~3 mils); calculated leak rate of $<1/10^{\text{th}}$ gallon per day per leak site
- Inspections showed dry material and salt nodule formation, minimizing the amount of salt waste outside of the pot
- Most likely cause is undetected weld discontinuities or defects during original manufacture
- Leaks sites will not grow during continued operation; if they are cracks, there is insufficient energy to drive crack growth
- The vessel is still structurally sound

- **Evaluated 19 Options against the following criteria:**
 - Salt Waste Processing Capacity, Regulatory Impact, Safety Basis Impact, Operability/Dose, System Impact, Cost, Schedule,
- **Four leading options**
 - Continue Operations with Enhanced Surveillance
 - Repair Evaporator Leak sites
 - Replace with New Evaporator
 - Alternate Path for DWPF Recycle
- **Recommended option - Operate with Enhanced Surveillance**

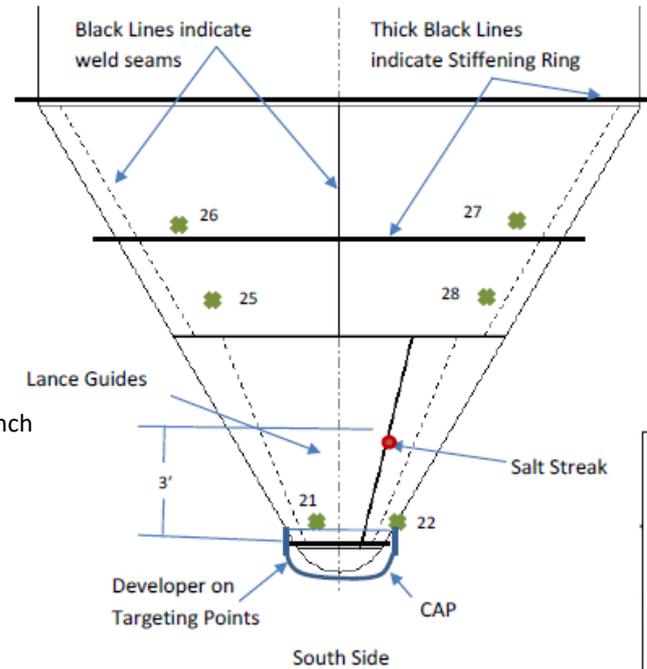
South Leak-site (the salt streak)

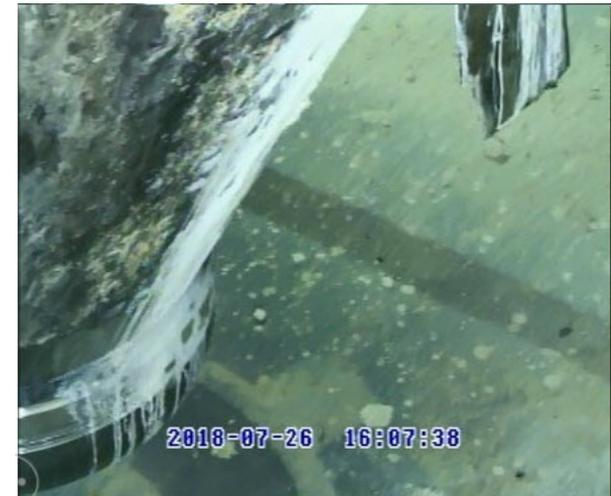
- Controls have been implemented to safely operate the 3H evaporator
- 3H Operations have resumed
- Periodic cell inspections indicate minimal leak rates as predicted by expert reviews
 - ~1 gallon of leakage since startup
- 3H evaporator space gain >300K gallons achieved since restart
- Sludge Batch 10 preparation continues

Leak site on 7/26/18

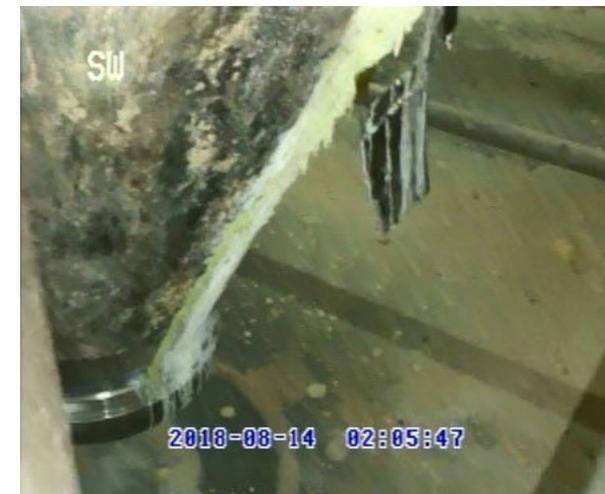
Leak site on 8/14/18
